## Harbourfront Fire Station, Toronto, Ontario

## Historic Tree Preservation at Alden Lane Nursery Livermore, California

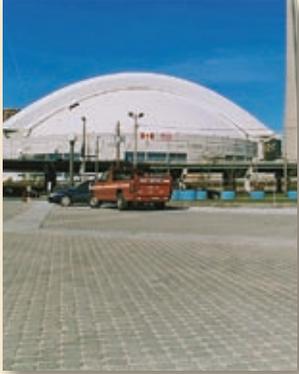
Adjacent to the Toronto SkyDome and the CN Tower in Toronto, this fire station uses PICP to reduce runoff pollutants entering nearby Lake Ontario.

Located on a Lake Ontario, the Harbourfront Fire Station features 11,000 sf (1,022 m<sup>2</sup>) of PICP in its entrance and parking lot. Built in the winter of 1998, the City of Toronto required a pavement that would reduce runoff pollution to Lake Ontario through infiltration while providing a parking lot in a highly urbanized area.

Built with a dense-graded base, the project exemplifies the ability of PICPs to withstand heavy loads from fire trucks in a winter environment with deep penetra-

tion of frost in pavements. The pavement is plowed and salted in the winter, but not sanded to prevent clogging of the aggregate in the openings and reduced infiltration. The lack of raised curbs enables snow plows to push snow directly off the pavement.

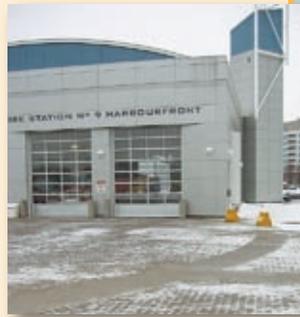
PICP withstands salt and snow plowing, a regular part of Toronto winters.

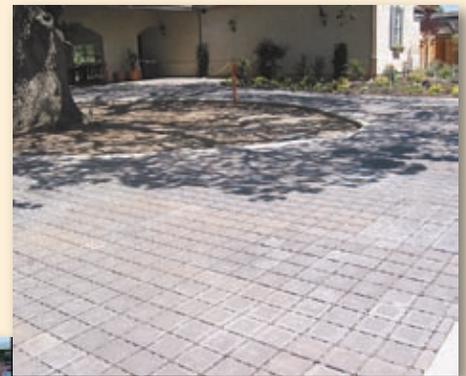
The sidewalk adjacent to the nursery entrance uses permeable paving units to return water to nearby vegetation.

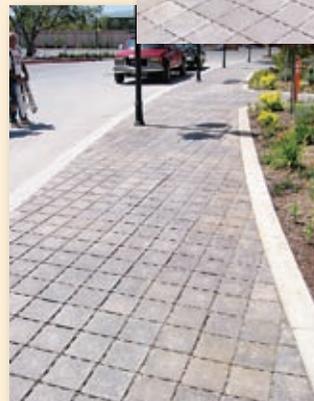
Roots feeding a 300 year-old oak tree receive additional air and water from permeable paving units at a landscape nursery in Livermore, California.

This upscale nursery in the San Francisco Bay area used 12,000 sf (1,115 m<sup>2</sup>) of environmentally friendly, mechanically installed PICP to allow air and water to nourish the roots of a very large, 300 year-old oak tree. It is so old it has been designated as a heritage tree which protects it from being removed. The tree lives in clay soil and PICP was built to ensure that additional air and water reach its roots. The nursery's owner decided on permeable pavers as a solution to preserve the historic tree and provide an environmentally sensitive entrance to the store. Local runoff regulations were not a significant motivating factor. The owner simply wanted to give the tree an opportunity to survive and grow.
